Report on
Fire Incident
At
XXXX Premise

Vadodara
Gujarat
India

Prepared By
IBS Gulf Design Pvt Ltd

Document Number:IBSGD/XXXX Vadodara/R1
Date Issued:27th July 2015
Project Description: Report on Fire Incident

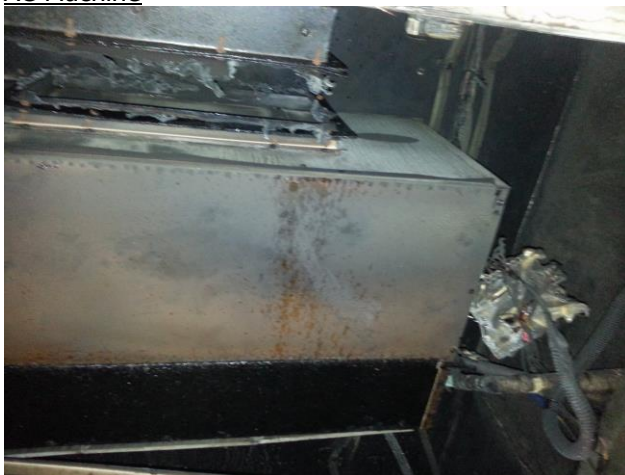
AC Machine

The Airconditioning units were examined closely. There were no indications that the fire had started from the unit and the extent of damage of the refrigerant piping, Pipe insulation and the flexible wiring etc were minimal as compared to other areas.(Pls refer to the Photo below) Hence probability of AC being the cause can be ruled out. Please see the picture below for reference.

4. The movement of the smoke indicates from a lower level climbing to the gypsum ceiling.
5. The AC machine and Lighting equipment are ruled out as explained earlier in the report.

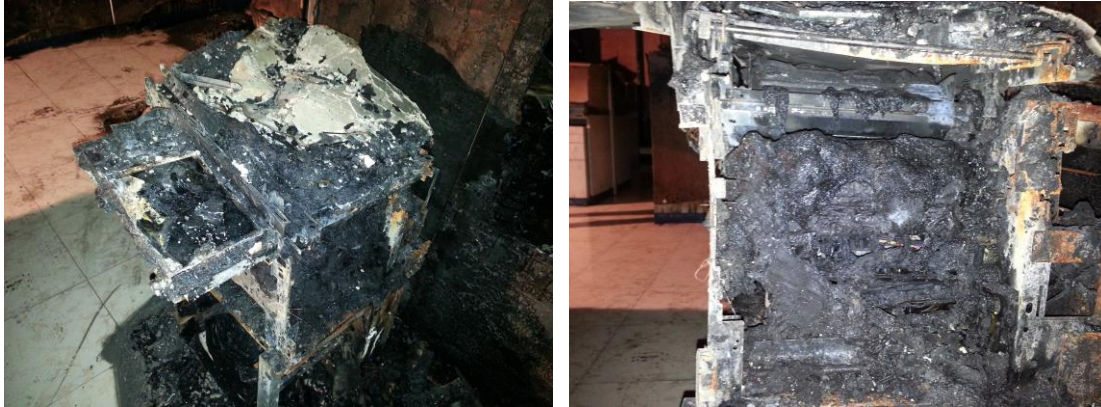
The area next to ID0023 seat (pls refer to the floor plan) houses the MFP M630 Laser jet printer. It was observed that the printer (see photo below) was the most affected equipment with practically the entire equipment including the internals charred beyond recognition. It must also be noted that the extent of damage is almost complete in the compartment housing the operating mechanism and the upper tray.

The area above the printer was also the most affected one with a structural beam taking the maximum heat and the plasters of the beam had given away due to excessive heat. The wooden partition besides the printer was totally damaged and the wall mounted storages mounted on the partition had fallen over the workstation desks and damaged the worktables.

6. The Printer has been the most affected equipment and is on the Raw power.
7. The area directly above the printer has suffered the maximum damage with the beam plasters coming apart.

The abnormality in the raw power voltage (could be an overvoltage as under voltage at early mornings when the grid is not loaded is unlikely) could have entered the Power supply unit of the printer and damaged the capacitors. This could have resulted in a spark or fire due to damage to capacitors. The toner in the printer would have acted as a catalyst to propagate it.

However, we recommend that YY, the OEM vendor of the printer, should carry out a thorough investigation of the affected parts of the printer and come out with a report.

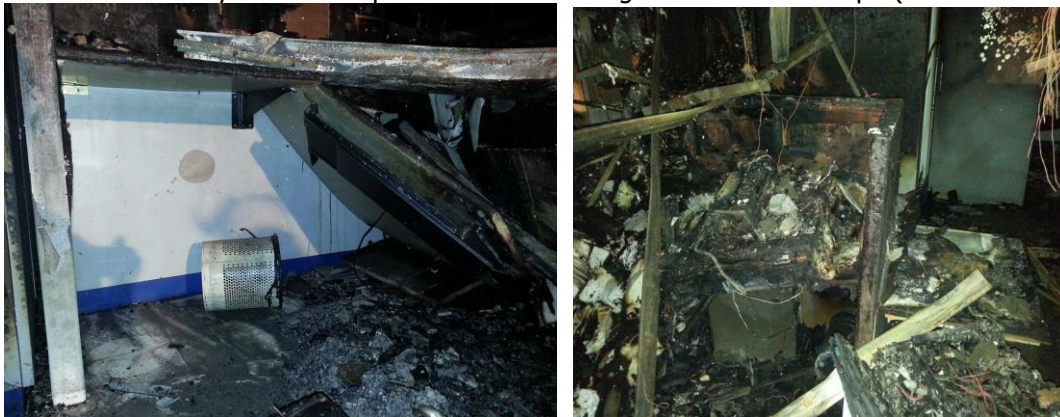
It was also noticed that there were bundles of papers kept on the workstation desks in the ICG area which have been totally burnt. The portion below the workstation desks where the CPUs and dust bins were kept were comparatively less damaged. In fact the dust bin in the ICG area below the workstation exactly behind the printer has not even got deformed in shape (See attached picture).

This indicates that the probable source of fire was not from below the workstations where CPUs were kept. The Fire had started elsewhere and started climbing upto the wooden partition, false ceiling and to the structural beam. Once in the false ceiling, the smoke had spread through AC ducts and the ceiling void.
