Report on
Power failure to OLD MER room
At
Xxxx Group Centre
Mumbai

Prepared By
H.Sriram
IBS Gulf Design Pvt Ltd

Version 1
January 2011

Document Number:IBSGD/XXXX CGC
Date Issued:28 Jan 2011
Project Description:Report on Power failure at Old MER Room at XXX

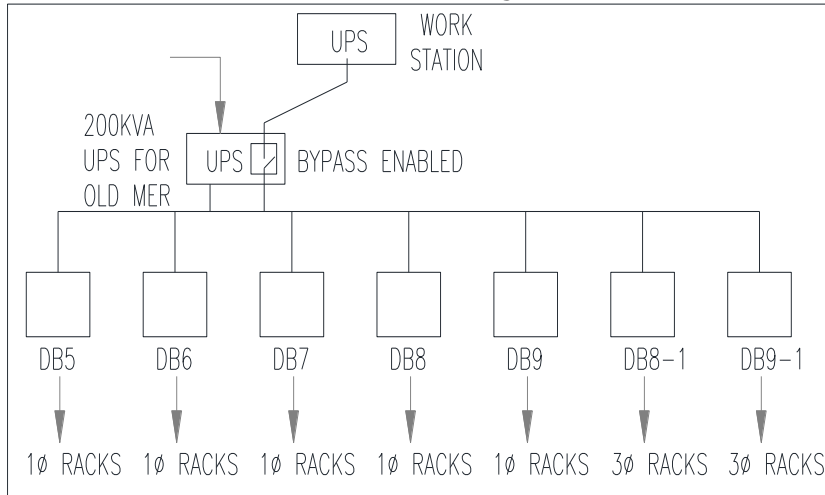
- The premise has an Old MER room powered by 1 x 200 KVA UPS , A Lan room powered by 1x 100 KVA UPS and a New MER room powered by 2 x 120 KVA UPS on N+N.

- There are 2 x 200 KVA UPS powering the workstation loads. One of the outputs from these UPS is connected to the bypass of the Old MER room UPS for redundancy purpose.

- The incoming to the Old MER UPS is 3 wire /3 phase and the neutral of the downstream distribution is derived at the UPS output side.
- The UPS is in the basement level and the distribution panel and DBs are at the 3rd floor level.

- There is no isolation transformer in the upstream/ downstream of the UPS.
- There is a dedicated earthing system available with earth pits.
- The power distribution, neutral connection, earth connection inside the MER room run under the false floor. The wiring is haphazardly done and there is no way to ascertain the correctness of wiring .

- Please refer to the schematic distribution arrangement for reference and understanding.

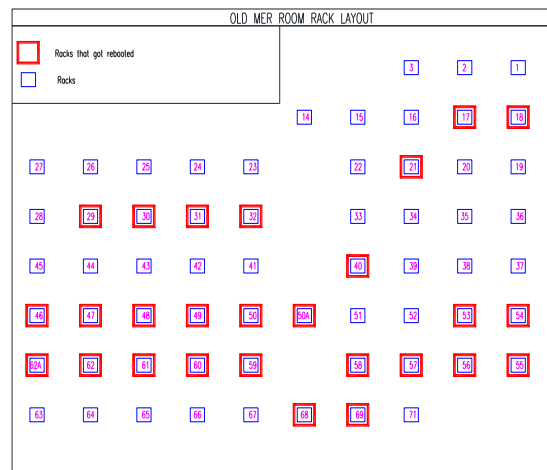
The attached sketch would explain the location of the racks with the details of racks that got rebooted.

It was observed that during the day of incidence that of the 63 racks, 27 racks got rebooted and the balance were unaffected.

A local disruption at the MER room level had happened. This disruption has not happened at the power as none of the ELCBs had tripped. Moreover all the racks supplied by the same circuit has not rebooted. For example UPS DB 6 Y4 supports rack 57, 69 and only 69 had rebooted.

Hence there seems to have been a disruption in the neutral or earthing circuit that has triggered this failure. It is possible that the racks that had got rebooted have a weaker SMPS in the processing unit and their capacitance could not sustain the power to racks during the interruption.

- To take a shut down of MER racks and thoroughly check the neutral and earth connections for tightness and continuity.
- To check if there is any earth cross connection between dedicated earth and protective earth as the false floor stands might be connected to protective earth.
- As a safety measure, create 2 additional earth pits and extend the dedicated earth to the new earth pits also.
- Properly identify the power circuits distribution in the form of as built drawing and labelling at DB and rack level.
- Separate the cross connections from different UPS to the same rack.
- Evenly distribute the load to all UPS DBs. IT was observed that DB 5, 6, 7 connected to most of the racks and UPS DB 8 & 9 are loaded less.
- Provide an Isolation transformer
- Provide surge arrestors at DBs.
